Capacity Building training on Climate-Resilient Water Safety Plan

**11-15 February, 2015
Butajira town, SNNP Region**

Summary of baseline data assessment on Climate Resilient Water Safety Plan for Butajira town water supply and sewerage service enterprise, Feb 2015.

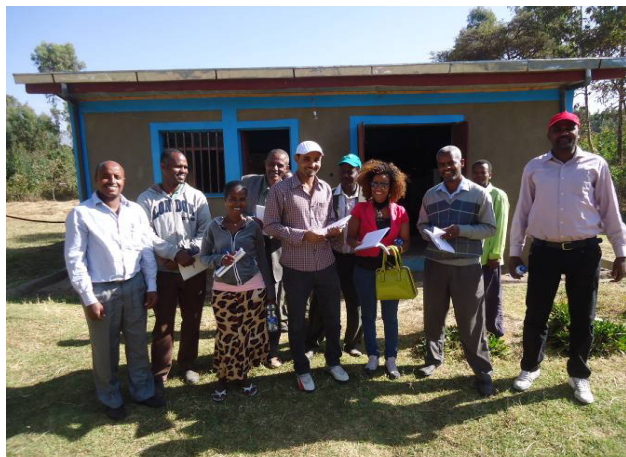
*Field visit, CRWSP training, borehole 3 Butajira town
Photo Eyob MoWIE 13 Feb 15*

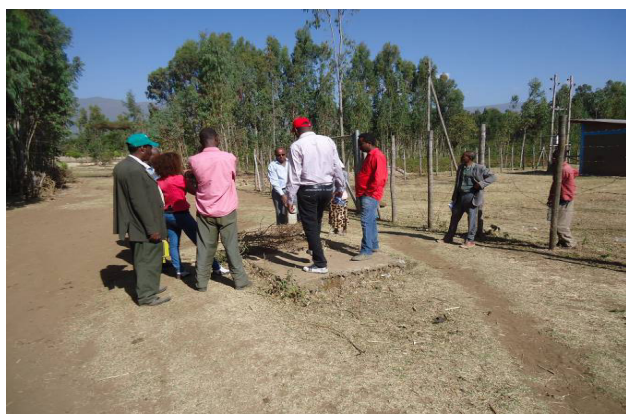
*Field visit, CRWSP training, borehole 1 & 2 junction point with
open manhole Butajira Town Photo Eyob MoWIE 13 Feb 2015*

Distribution	Contamination of water due to old/damaged/leaked pipelines and absence of manhole covers at pipeline junctions to solid and liquid wastes and run offs	Microbial & physical	Maintain damaged pipe lines			✓	Reported that they are regularly maintaining damaged pipes.	2	3	6	H	✓		Regularly maintain damaged pipelines, replace old pipelines and construct cover for more than 20 open manholes in distribution lines.
Distribution	Contamination and wastage of water in public water stand points due to absence/damaged fence	Microbial & physical	Fence			✓	It is observed that public water points has no fence or with damaged fence	3	3	9	H	✓		Construct /maintain fence with secured gate, replace damaged faucet and maintain check valve.
Consumer Practice	Contamination of water at HH level due to un clean storage containers, poor basic sanitation and hygienic practice	Microbial	Hygiene promotion activities			✓	Observation showed that HH store water in Un clean container, poor compound sanitation and hygienic practice. Dirty/algae plastic hose used to fetch water from tap	2	3	6	H	✓		Hygiene promotion activity Promote basic sanitation activities

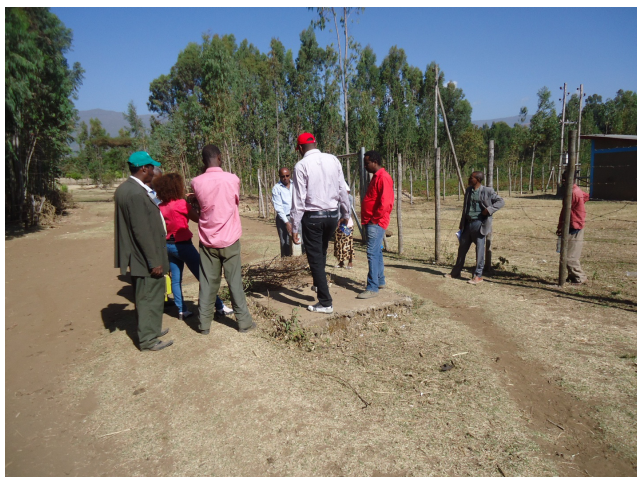
Field Visit CRWSP near to water source junction point open manhole photo Eyob, MoWIE, 13Feb 15

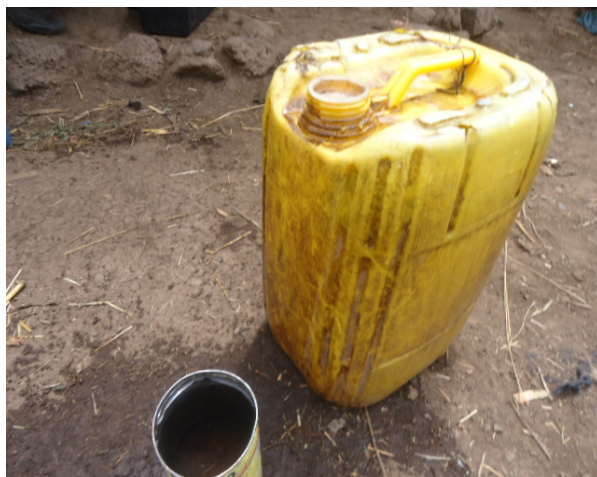
Field visit on CRWSP, a HH using dirty jerrican to store water, Ellie kebele, photo Osman WHO, 11 June 2015

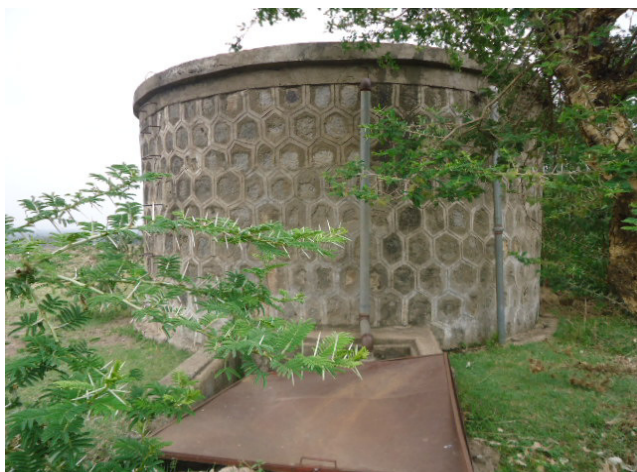
Field visit on CRWSP, reservoir with no fence and damaged manhole, Ellie kebele, photo Osman WHO, 11 June 2015

9	Maintain source well head	Risk of Physical and microbial contamination of water from runoff	WASHCO Woreda Water Office	30,000.00	April-June 15	Not started
10	Construct proper fence around the reservoir and remove nearby eucalyptus trees	Risk of microbial contamination of water due to wastes around the reservoir	Woreda Water Office, WASHCO & CRWSP team	42,060.00	April-June 15	Not started
11	Reinforce the existing fence for 4 public water points and replace damaged faucets	Risk of microbial contamination of water due to different wastes around public water points	WASHCO / Woreda Water Office	80,000.00	April-June 15	Not started
12	Supportive supervision, monitoring and review of CR WSPs		WASHCO Woreda Water Office	30,000.00	April-June 15	Not started
	Total			761,060.00

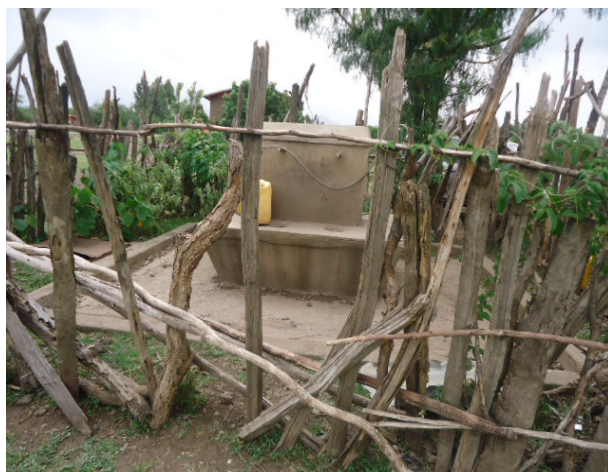
Field visit on CRWSP, public water point with damaged fence, Ellie kebele, photo Osman WHO, 11 June 2015

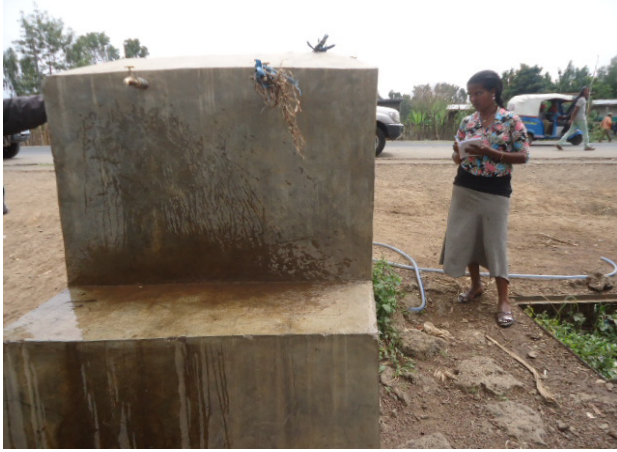
Field visit on CRWSP, public water point with no fence, open manhole with full of dirt and damaged faucet, Butajira town, photo Osman WHO, 13 June 2015

8	Construct/Reinforce the existing fence of public water points and replace damaged faucets	Risk of microbial contamination of water due to different wastes around public water points	Butajira town Water Supply Service	398,000.00	April-June 15	Not started
9	Maintain fence around the reservoir #2 located near to Butajira Health center	Risk of microbial contamination of water due to solid and liquid wastes around the reservoirs	Butajira town Water Supply Service	20,000.00	April-June 15	Not started
10	Supportive supervision, monitoring and review of CR WSPs		Butajira town Water Supply Service	40,000.00	April-June 15	Not started
	Total			1,772,653.00

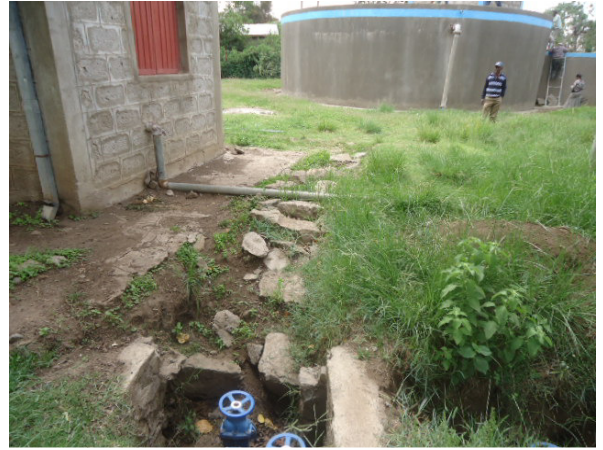
Field visit on CRWSP, open inlet manhole in one of the reservoir at Butajira town, photo Osman WHO, 13 June 15

Catchment	Contamination of water sources due to leakage at well head only at source #2	Microbial Physical	None		✓			2	3	6	H	✓		Maintain leakage at well head in source #2 back of town police station
Storage/Reservoir	Contamination of water due to damaged fencing at reservoir #2 near to Butajira Health Center	Microbial	Improper Fence		✓			1	3	3	M	✓		Maintain damaged fence around the Reservoir #2 located near to the Health center.
Storage/reservoir	Contamination of water due to open inlet manhole and nearby latrine facility	Microbial	None		✓			1	3	6	M	✓		Construct manhole cover and relocate the nearby latrine facility

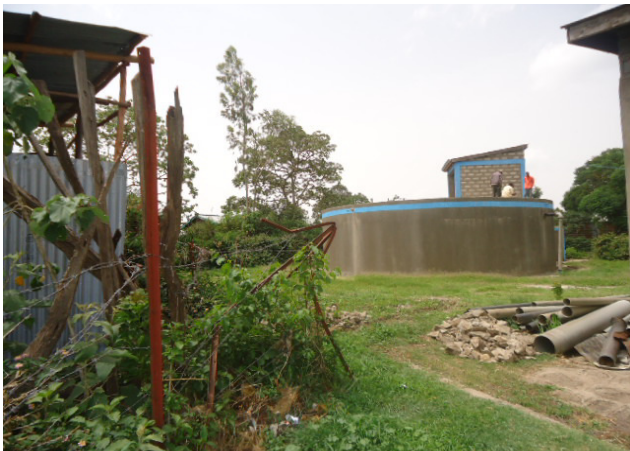
Field visit on CRWSP, latrine facility near to the reservoir, Butajira town, photo Osman WHO, 13 April 2015

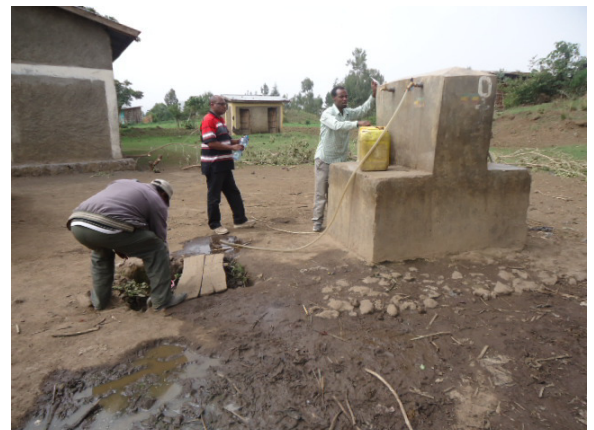
Field visit on CRWSP, public water point with no fence and open manhole around a health post, Butajira town, photo Osman WHO, 13 June 2015
