## Capacity Building training on Climate-Resilient Water Safety Plan

**19-30 Dec, 2015**  
**Adigrat & Fatsi towns, Tigray Region**

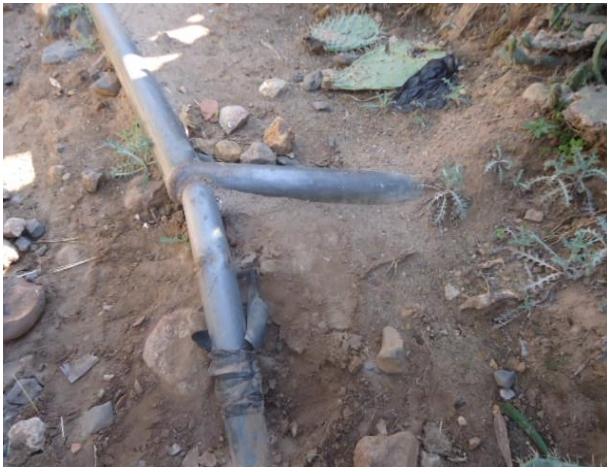
*Damaged pipeline and covered with plastic: CR-WSP training, Adigrat town photo Osman WHO, 21 Dec 2015*

Distribution	Contamination of water exposed pipelines	Physical Microbial Chemical	None					2	2	4	M	√		Supporting the suspended pipe with concrete stand
	Risk of contamination of water due to supporting wall of the stand post are being demolished as not fenced	Physical Microbial	None					2	2	4	M	√		Fencing the stand post Maintain the supporting wall of this stand post (Bono)
	Risk of contamination of water at public water points due to absence of drainage	Microbial	None					2	3	6	H	√		Constructing drainage to each Public water points
Users	The water is exposed to microbial and physical contamination due to inadequate care and improper utilization of water at home.	Microbial Physical	None					3	3	9	H	√		Conducting public awareness on safe water storage & use at home
	Risk of microbial contamination of water due to cow dung accumulated near to water meter of the tap	Microbial	None					3	3	9	H	√		Removing the cow dung immediately Relocating the pipe and its accessories and put the water elevated from the ground

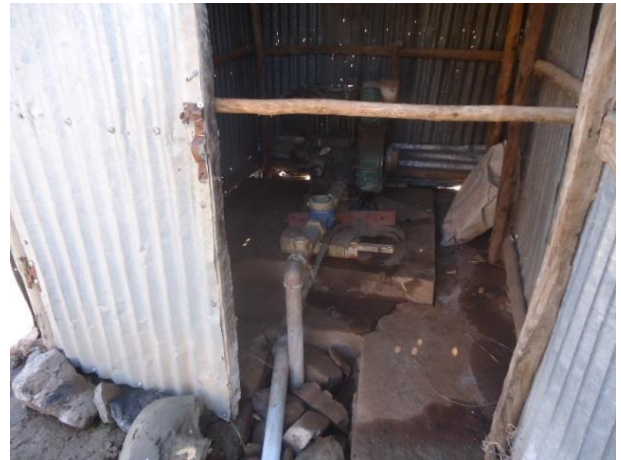
*A deep well water source with cracked/damaged well head Fatsi town, photo Osman WHO, 27 Dec 2015*

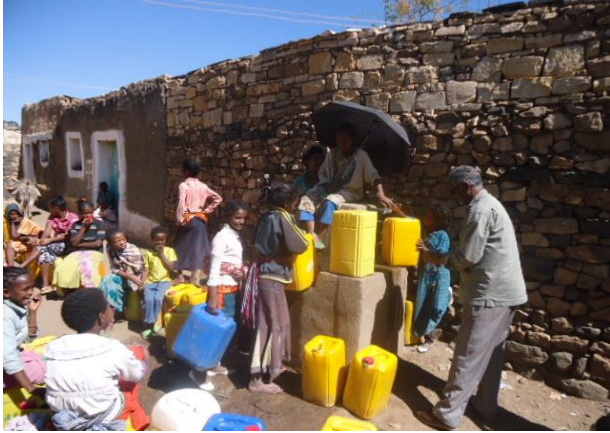
*Community members fetching water at public water point with no fence and sited in the roadside, Adigrat town, photo Osman WHO, 21 Dec 2015*

13	Fencing public water points and constructing drainage to each public water stands	Risk of water contamination due to public water points are not fenced and have no proper drainage system	Water utility office	March-April 16	450,000.00	
14	Monitoring and Evaluating the implementation of CRWSP				20,000.00	
	<b>Total</b>				<b>3,763,000.00</b>

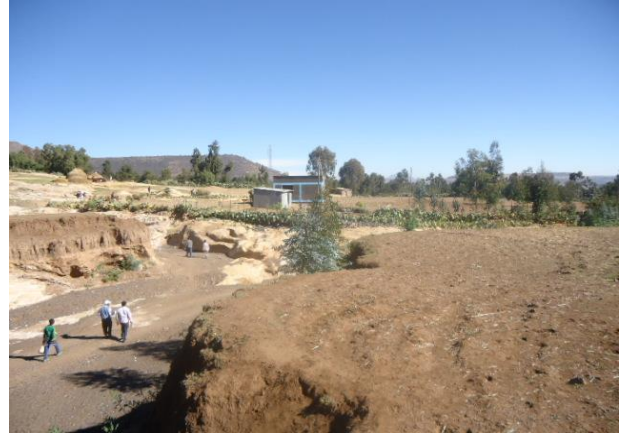
*Large gully near to a deep well water source, Adigrat town, photo Osman WHO, 21 Dec 2015*

Catchment BH8, BH9	Presence of gully nearby the water source exposed the water to damage	Physical	None		✓			3	2	6	H	✓		Building check dams Building retaining wall Carrying out soil & water conservation at the upper part of the catchment area

4	Building check dams and retaining wall	Water source exposed to damage due to the presence of gully nearby the source	Environmental Protection, Water utility, Agriculture & Urban development Sectors	March-May16	1,250,000.00	Involving community participation
5	Carrying out soil & water conservation at the upper part of the catchment area	Water recharge reduced due to degraded catchment area	Agriculture Office Water Utility Environmental protection	10/08-11/08	100,000.00	Involving community participation
6	Providing adequate training on water treatment using chlorine to water quality professionals and checking residual chlorine regularly	Water is liable to microbial and/or chemical contamination as the dose is under and/or over due to residual chlorine checking is not carried out	Regional Water Bureau Water Utility	March 16	3,000.00	
7	Preparing SOP of chlorination	Water is liable to microbial and/or chemical contamination as the dose is under and/or over due to residual chlorine checking is not carried out	Water Utility Office	March 16

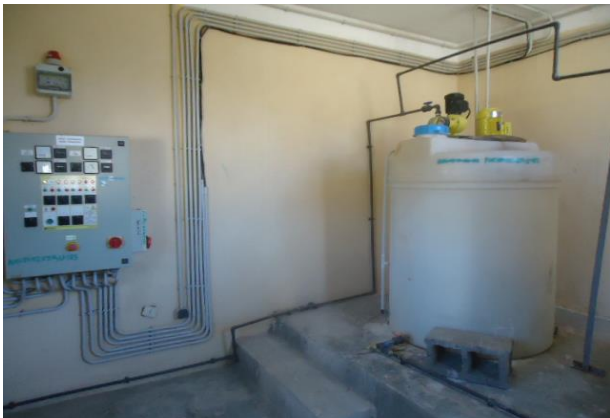
*Automatic chlorination system for Adigrat town community water supply photo, Osman WHO, 21 Dec 2015*

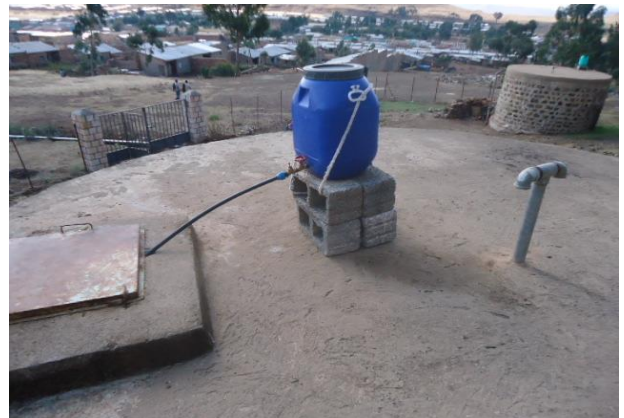
*Community water treatment practice using drop system in the reservoir, Fatsi town, photo Osman WHO, 21 Dec 2015*
