# **Implementation of Climate Resilient Water Safety Plan In 4 Pourashava**

**Ground Water Circle  
Department of Public Health Engineering**

**December 2015**

**Implementation of Climate Resilient Water  
Safety Plan (WSP) in Water Supply Systems of  
Four Pourashava**

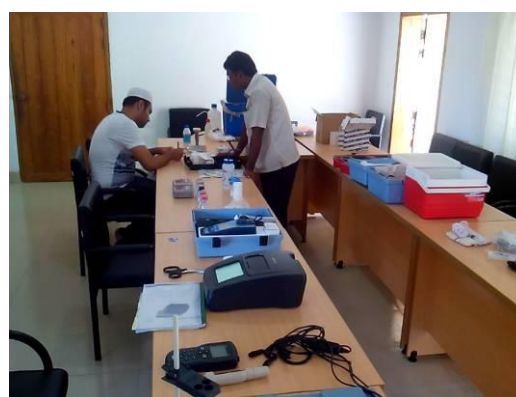
Figure 3: Photograph of Water Quality Testing  
At Cox's Bazar

A water quality testing was conducted by Assistant Engineer, Ground Water Circle of DPHE in each of the Pourashava water supply system to identify the water quality hazards. DPHE also facilitated collection of samples from different points of water supply systems in each of the four Pourashavas. Five water quality parameters were tested for each of the collected samples from production tube well and treatment plant and two parameters were tested for samples collected from water collection points for users. For production tube well samples, the tested parameters were Arsenic (As), Iron (Fe), Manganese (Mn), E. Coli and Electrical Conductivity (EC). For samples collected from user points, only E. Coli and Electrical Conductivity were tested. The As, Fe and Mn tests were carried out at the laboratory of Bangladesh University of Engineering and Technology (BUET), and the E. Coli and EC tests were carried out using portable field testing kits. For each ward in a Pourashava, at least three samples from each o wards of each o the Pourashava. While analysing the water quality results, concentration of As and E. Coli was

given priority to assess chemical and microbial risk respectively. If concentration of As was found < 0.05 mg/l, then the chemical risk was assumed to be "low" else high. For E. Coli concentration, the risk classification was done as below:

The water quality test results indicated that arsenic (As) was not posing any threat to water quality in any of the four Pourashavas. Fe concentration was found above acceptable limit in Naogaon, Ullahpara and Birampur Pourashavas which created an aesthetic problem among the users. Only in Ullahpara Pourashava Mn concentration was found above critical limit. Salinity is a threat in Cox's Bazar Pourashava supply water. The microbial risk was found significant in all the Pourashavas at the water collection points for users, as most of the tested samples showed high concentration of E. Coli in tested water. Therefore, the WSP needs to identify the challenges in water supply systems through hazard analysis and take proper control measure to improve the microbial quality of water at user's end. Technical detail with of the overall assessment of water quality is presented in the Table 2.

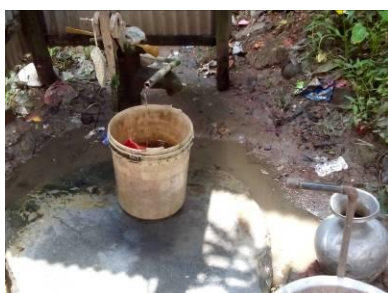
Their awareness can removed various types of wrongdoing for safe water consumption of the consumers as observed during the KAP survey. The major constrains at household level are no/faulty tap in the household connection, broken platform, unclean surroundings, unclean underground and overhead tanks (some are presented in the following) etc. The water users were informed about these problems and motivated for corrections so that the safe water consumption is assured.

No Tap of Household

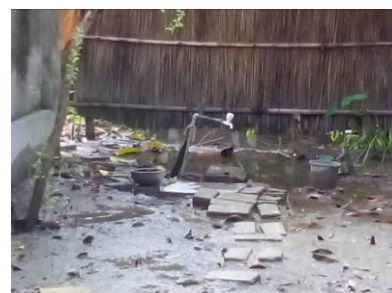
No platform & unclean surroundings

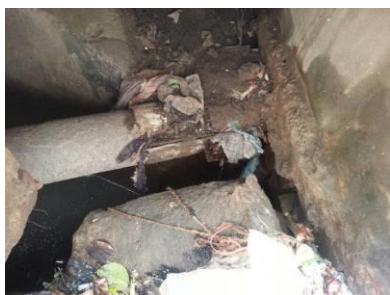
Exposed pipeline

Considering these the activities performed were mainly related with sluice valve chamber, pipe line leakage, wash out system, treatment plant maintenance, cleaning of system etc. The lists of works performed mainly are:

- Installation of new sluice valves and gate valves where needed
- Construction of chambers for new sluice and gate valves, and providing cover slab
- Filling of the sluice valve chambers with sand
- Increasing height of sluice valve chambers above the road/drain level where required
- Improvement of sanitary seal's condition at PTW
- Installation of chlorine dosing system in the water supply system
- Using pipe drilling device and rubber gasket during providing house connection
- Cleaning of sluice valve chambers, treatment plant, overhead tank, clear water reservoir etc.
- Improvement of wash out systems and installation of required new wash out systems where required
- Repairing of leakages in pipe network and providing casing pipes to protect house connections from wastewater when crossing drains

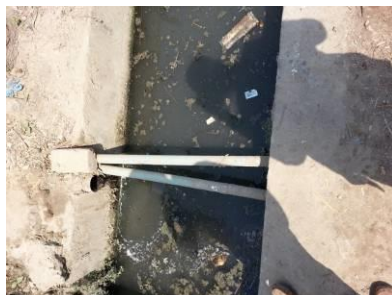
Connection Over the drain

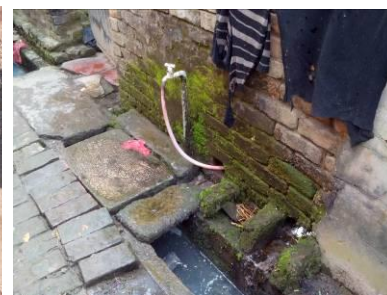
Water point over the drain

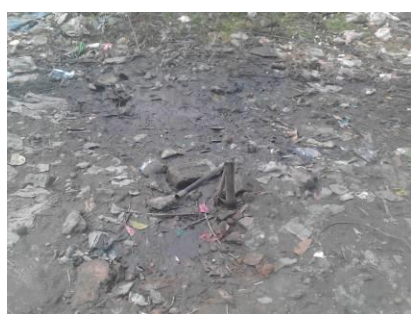
Illegal Connection

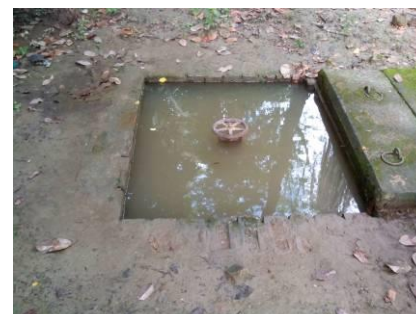
Sluice valve Chamber
